Phase I - Environmental Site Assessment and Remediation Program

Former Appletex Mill
116-122 Old Mill Lane
Appleton, Ontario

November 15, 2010

Report: PE1114-REP.02

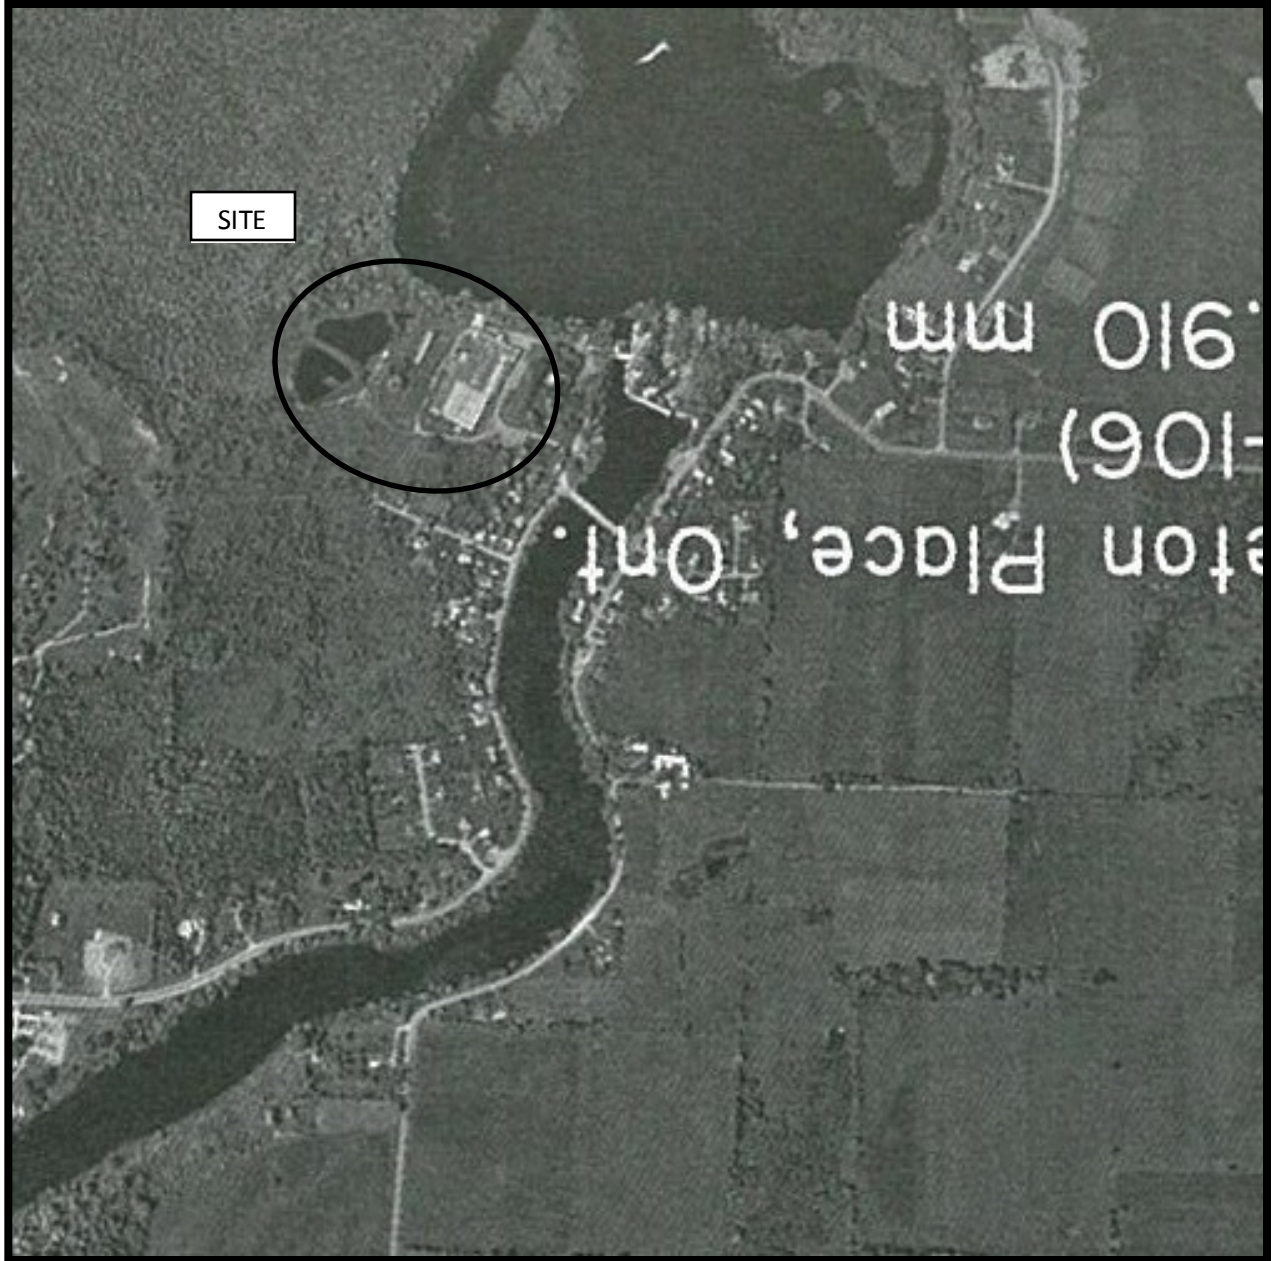
AERIAL PHOTOGRAPH
1994

- 1981 No significant changes have been made to the subject site or surrounding properties.
- 1994 There are now three (3) lagoons on the west portion of the site, separated by berms. No evidence of soil disturbances are evident on the southwest portion of the site. No other significant changes have been made to the subject site or surrounding properties.

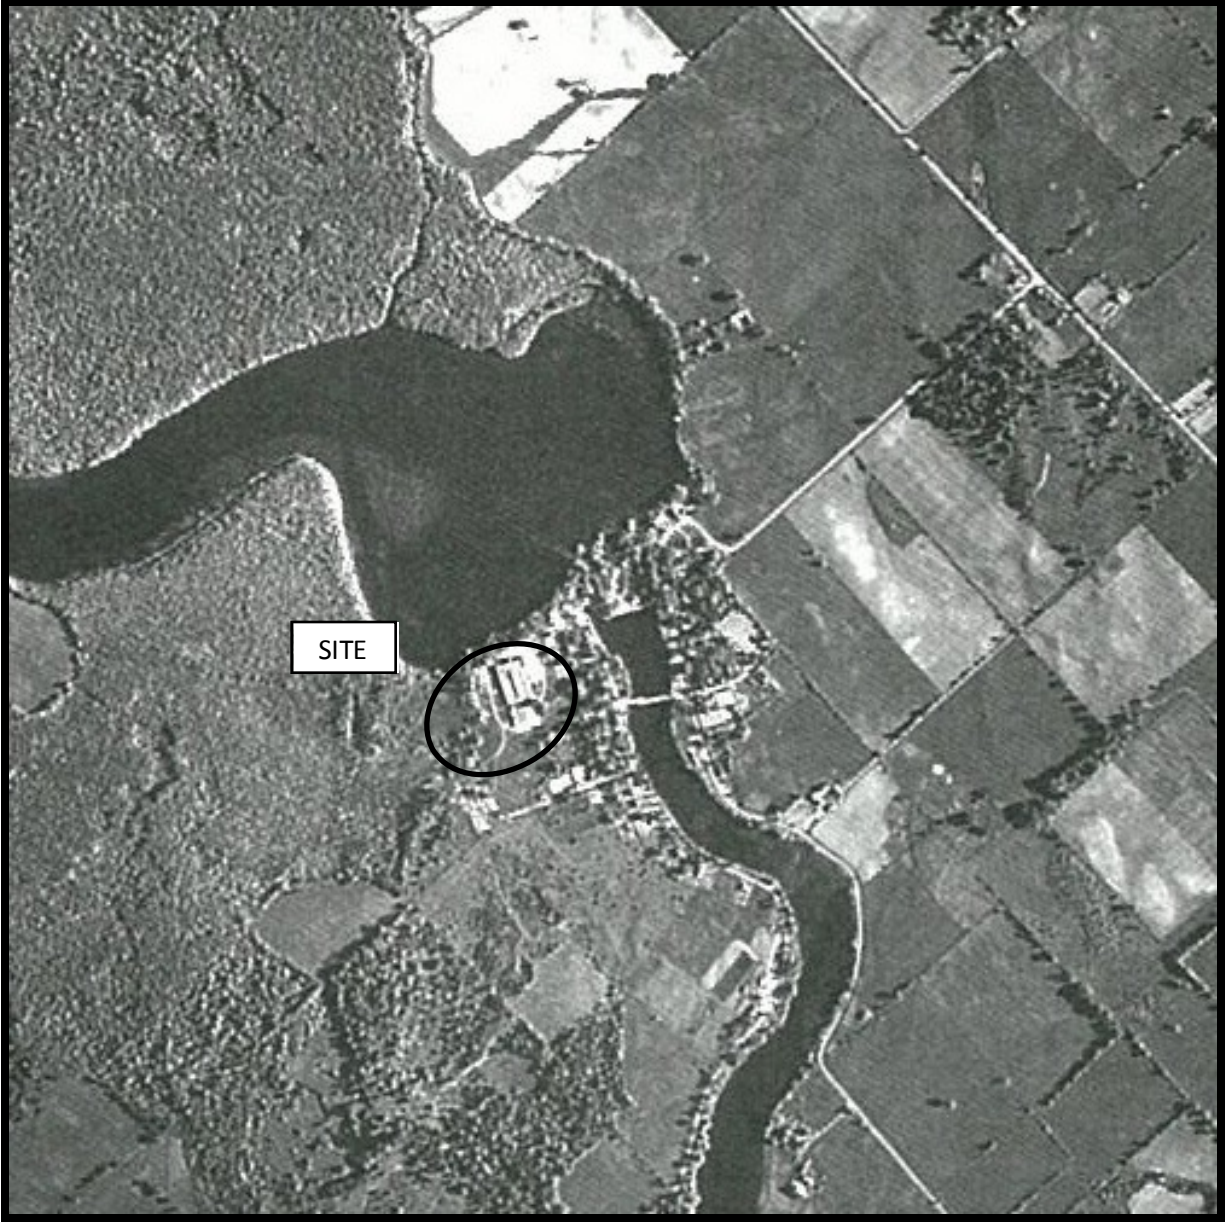
AERIAL PHOTOGRAPH
1959

- 1959 The subject site has been developed with the mill building structure on the northern portion of the site. Several access roadways appear to have been constructed around the building and to the southwest portion of the property. Some soil disturbances/fill placement were observed on the southwest portion of the property. The properties to the east and southeast of the site, west of the Mississippi River are occupied by residential dwellings. Surrounding properties to the northwest, west and southwest are vacant treed land. A bay of the Mississippi River is present to the north of the site.
